AN/SPS-39, 42 RADAR-IMPROVED TWT OPERATION

AN/UNQ-7 ELIMINATION OF SHOCK HAZARD

ORIGINAL**AN/URN-3 EMERGENCY REPAIR OF TACAN ANTENNA**

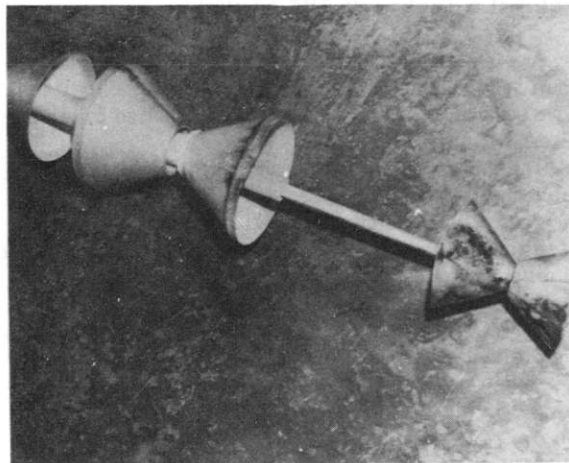
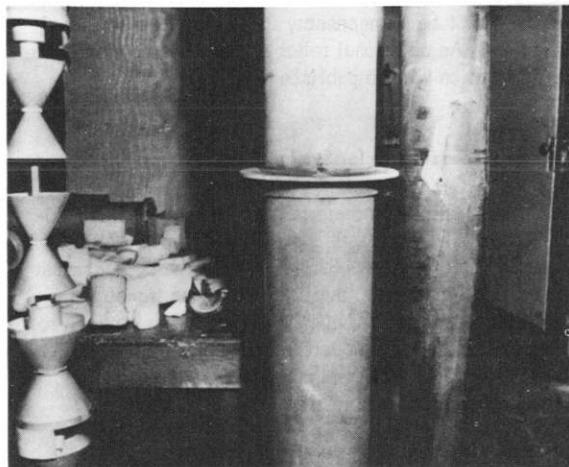
The casualty resulted from arcing, between the fixed array and the rotating element, which apparently had been caused by excessive vibration or shock. The fixed array (low band array assembly) was of a type that is being replaced by a field change, and the change had not been made in this instance.

The damage to certain parts of the assembly can be seen in figures 1 and 2. The fixed array was severely damaged and was replaced. The second conical element from the top was badly burned and physically deformed, and the support tube for the elements was bent in that region. The surface of the cover for the array was burned and broken also. The inner of the two cylinders of the rotating element was subjected to the discharge immediately above the mid supporting flange and circumferentially in the area in which the parasitic element is placed. The surface was punctured, the flange was burned, and area extending out from the hole for about 2 inches was discolored owing to the heat of the discharge, and the parasitic element was shorted. The damage to the outer cylinder of the rotating element consisted of the shorting of one of the nine parasitic elements.

To repair the cylinders of the rotating element it was necessary to obtain a suitable replacement for the wire contained in the shorted parasitic elements. An examination of a sample removed from the inner cylinder indicated a resistance factor of approximately 2,000 ohms per meter. No standard stock replacement being available, a search of the Japanese market was made. A high-quality Nichrome type of wire with a resistance factor of 1,000 ohms per meter was procured as the nearest substitute obtainable. This wire was used in the repair process now to be described.

Inner and outer dies were formed of 1/8-inch steel. When the inner die was in place and an appropriate separating film had been inserted, seven layers of resin-impregnated glass were applied over the cut-out area. (Material used: FSN 2040-372-6046 Plastic Repair Kit.) The outer die was then clamped in place, and the patch was allowed to cure for 6 hours.

A section of the mid flange that had been damaged in the discharge was cast and fitted into place on the cylinder. The final operation was one of finishing the surface and balancing the cylinder.

The repair of the outer cylinder of the rotating element followed nearly the same steps described above. Although only one of the nine parasitic elements had been affected, to insure uniformity all nine were replaced. Note: Elements in the outer cylinder consist of two parallel rows of wire, one row embedded in the middle of the cylinder wall and the other near the inner surface. Only the latter row was damaged and replaced. Because of this fact, all work was done on the inner wall of this cylinder.

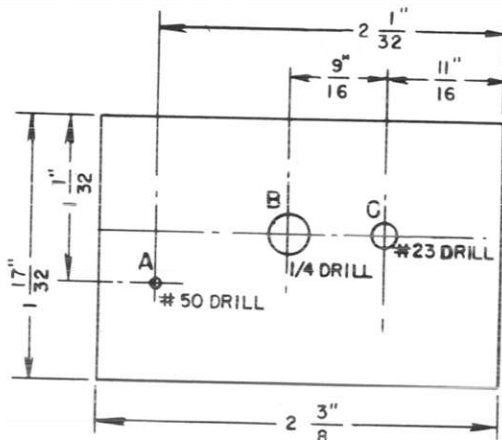
A method by which these pins may be removed and replaced without removing the front panel has been suggested. This can be done by modifying the present limit stop system as shown in the figure and by following the accompanying instructions.

TEMPLATE SHOULD BE APPROX. 1/16" THICK EXACT DIMENSIONS ARE SHOWN COUNTERSINK

HOLE C FOR #6 FLAT HEAD MACH. SCREW
HOLE B USE 1/4 DRILL
HOLE A USE #50 DRILL

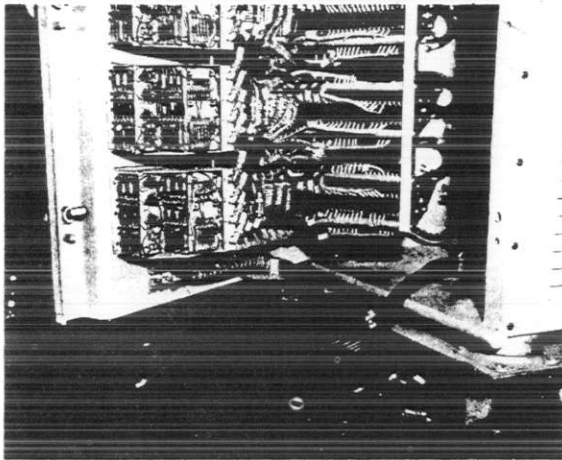
Figure 1 - Door Closing without Cable Spring.

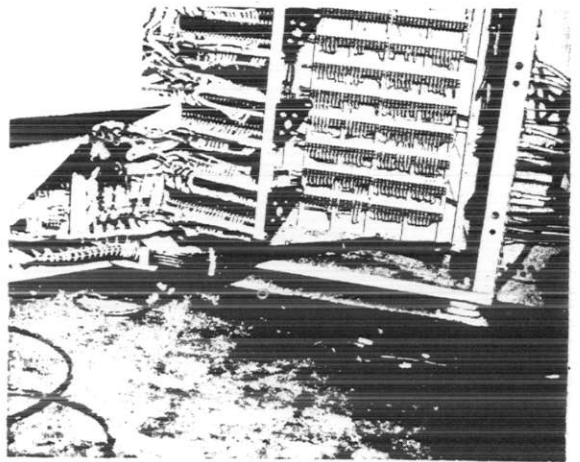
Figure 2 - Door Closing with Cable Spring.

1. One close wound spring 5/8" O.D., 12" long, No. 14 spring wire.
2. One 12" piece of 3/4" synthetic tubing to insulate spring.
3. One Timmerman No. 19A insulated cable slip, or equivalent.

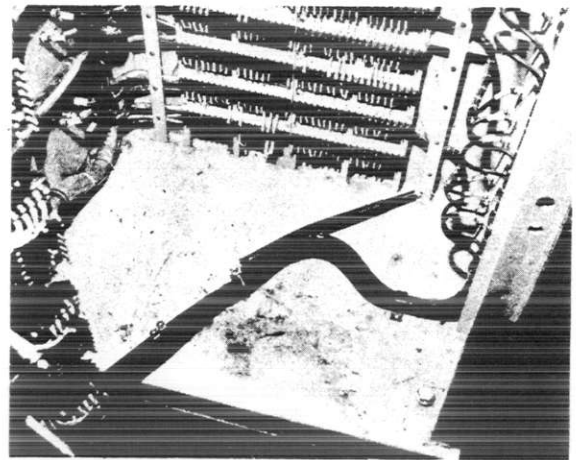
Figure 3 - Equipment showing cable spring and clamp in operation.
