ELIMINATING SO-a INTERFERENCE TO TCS RECEIVERS

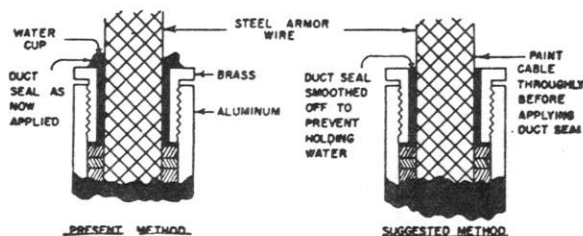
Rusting of Armor at Terminal Tubes: The greater part of rust found occurred where the armor passed into the stuffing tubes. The armor is made of steel wire, painted with aluminum paint. It was found that the stuffing tubes were made of aluminum and the gland nuts were made of brass, unplated. Furthermore, the "duct seal" was applied in such a manner that a cup was formed allowing the retention of water; both fresh from rain, and salt from spray, etc., around the gland nut and cable, thus promoting electrolytic action. Under these conditions, the steel in the armor will be first to corrode.

FIGURE 1.—Left, present method; right, suggested method.

- Substitution of aluminum gland nuts for the brass now used.
- Thorough painting of the armor well down into the gland nut prior to the application of "duct seal."
- Proper finishing off of the "duct seal." Frequent inspection to prevent formation of the water cup as a result of cable movement is desirable. Figure 1 shows what was found together with a suggested finishing method.

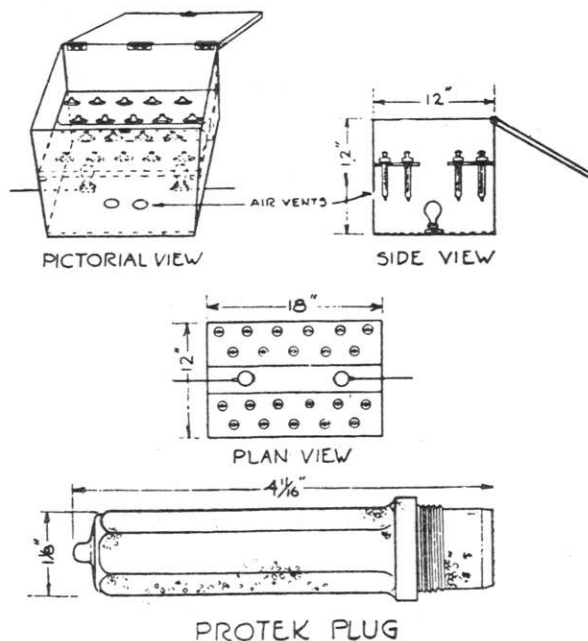
FIGURE 1.—Device for drying Protek plug.

A simple device for drying the plugs is shown in figure 1 and consists of a wooden box (dimensions given are approximate) with hinged cover. The front panel has two holes drilled out for air vents. Two shelves are mounted in the box as shown in drawings. The holes for holding the Protek plugs are 1-3/16 inches or just large enough for the insertion and removal of the plugs with ease. Two ordinary 100 watt light lamps are used to generate the heat.

- a. Place the pink plugs in vertical position on shelves.
- b. Light the lamps and close the cover.
- c. When the Protek plugs turn blue the reactivating process is completed.
- d. Seal the open end of the Protek plugs with scotch tape or similar material to keep the ends sealed until they are inserted in the equipment.

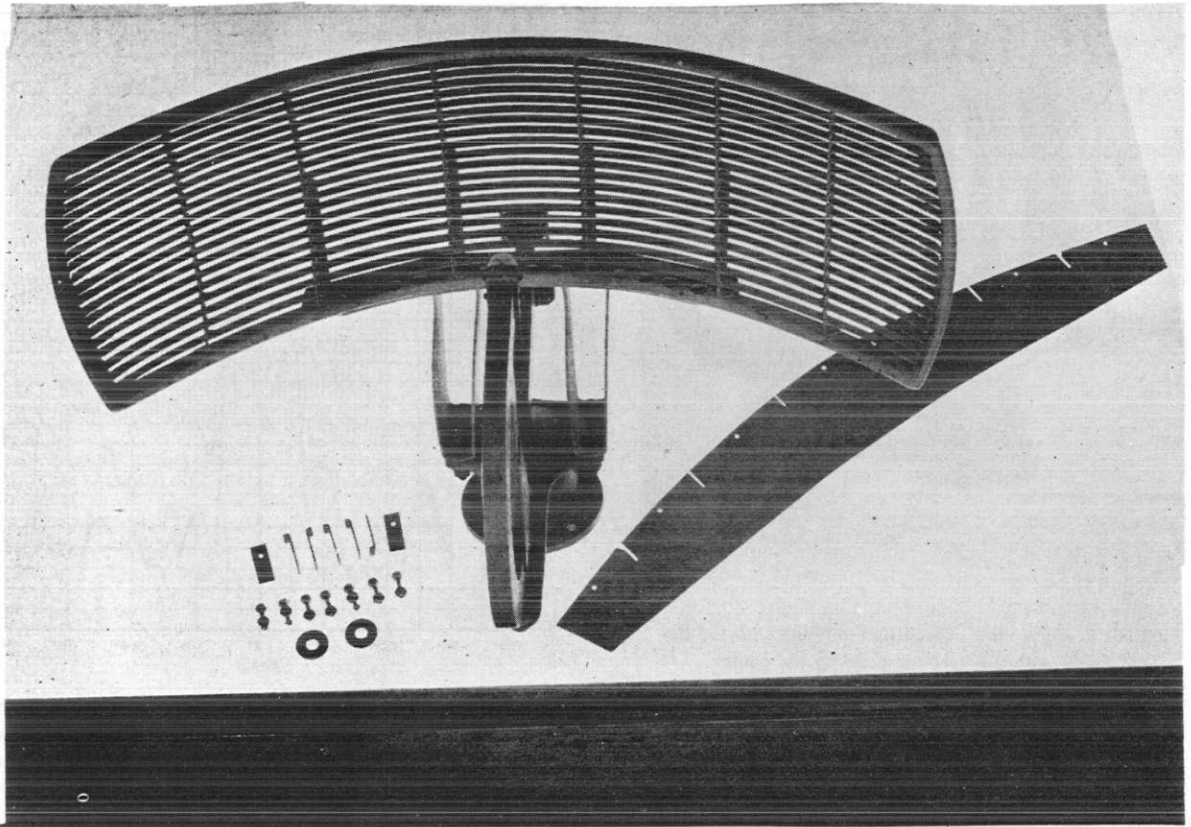
FIGURE 1.—Disassembled view of modified SO-3 antenna. The new reflector strip is shown to the right and mounting hardware to the left. The tapped screw holes along the bottom rim of the main reflector should be disregarded as they are not used in the final strip attachment.

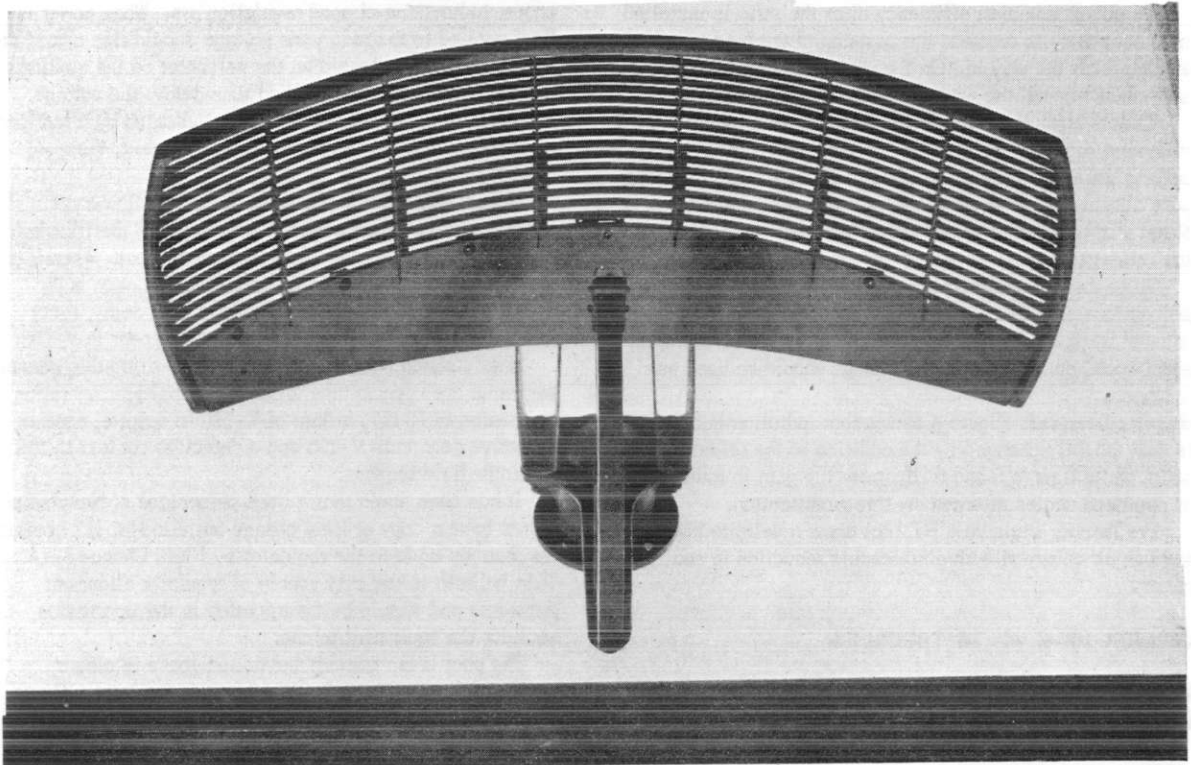
FIGURE 2.—View of modified SO-3 antenna with reflector strip attached. Note that the strip extends two inches up into the main reflector.

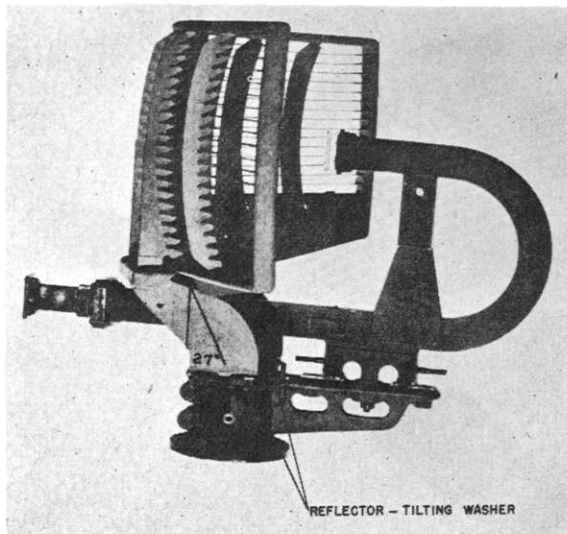
FIGURE 3.—Side view of modified antenna showing the 27° angle with the vertical made by the center section of strip, the reflector tilting washers, and the position of the fastening clamps.

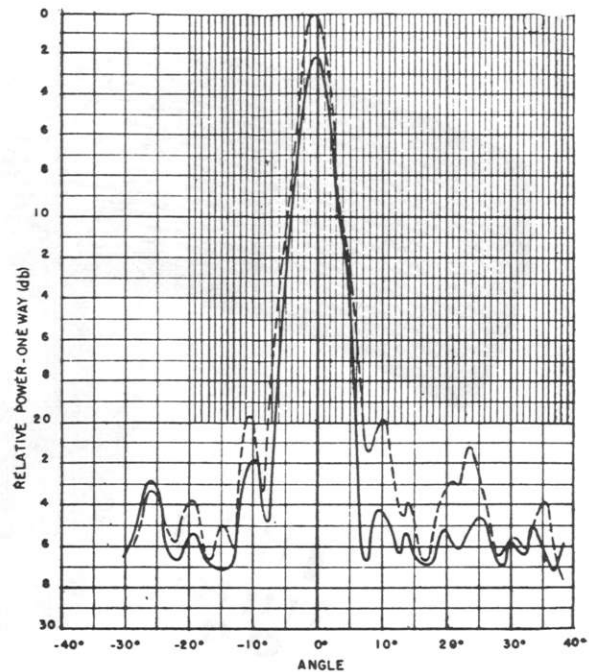
FIGURE 4.—Comparison of radiation in azimuth from the modified reflector (solid line) and the unmodified reflector (dashed line). Note that the normal beam is not affected by the modification except for loss in gain.

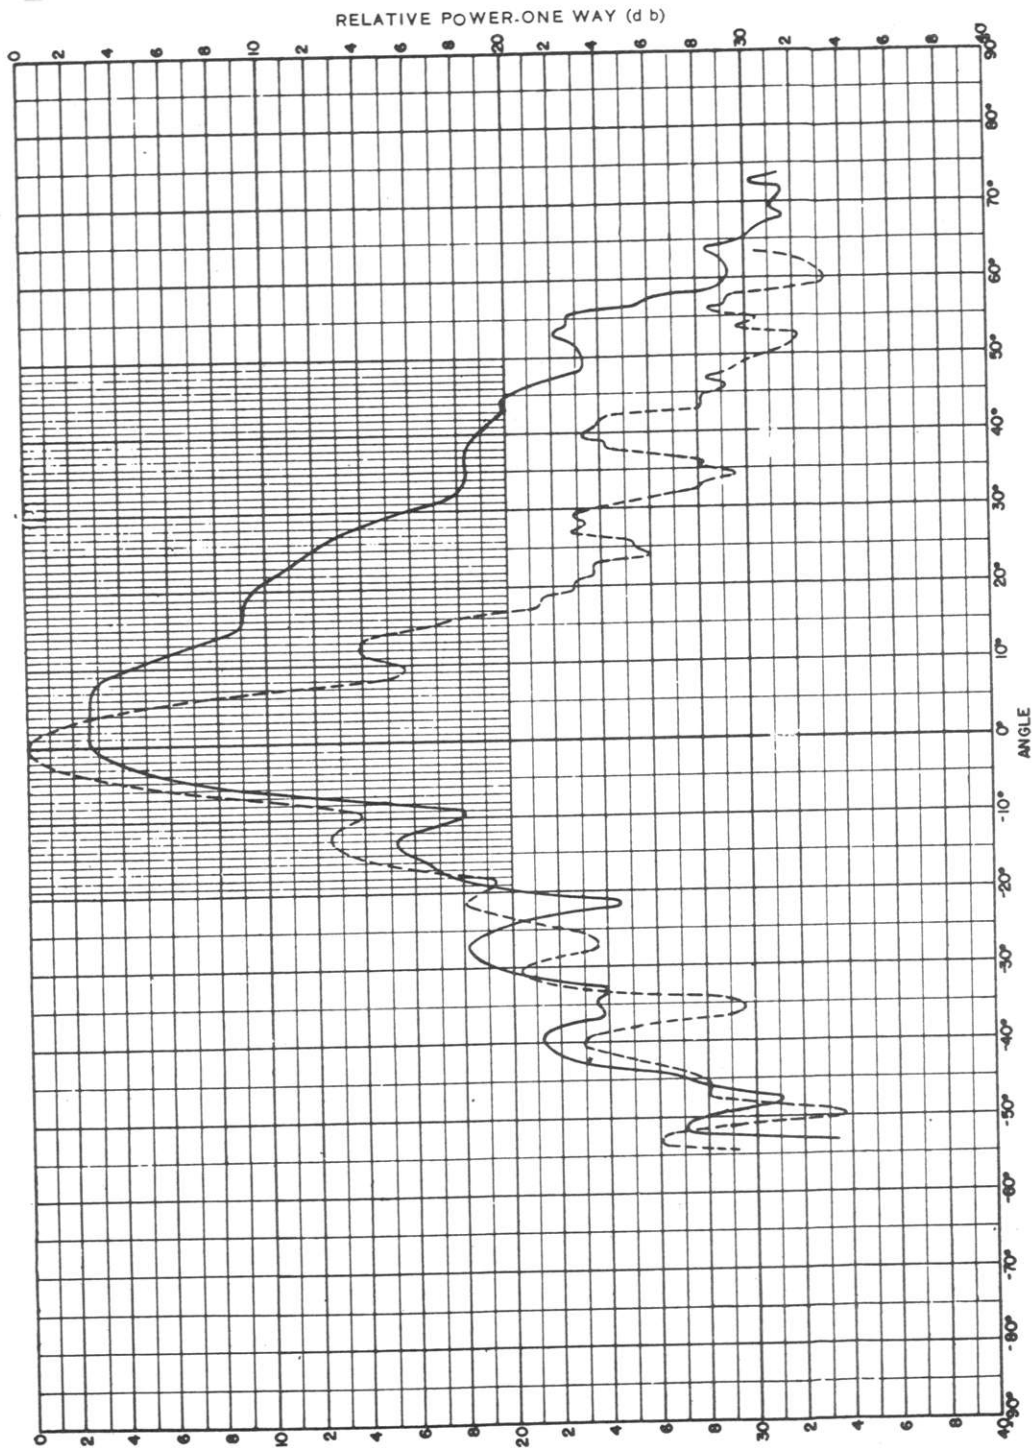
FIGURE 6.—Elevation pattern showing the increase in radiation at overhead angles with the modified reflector (solid line) over the unmodified reflector (dashed line). The water side is on the left and overhead angles to the right on this diagram.

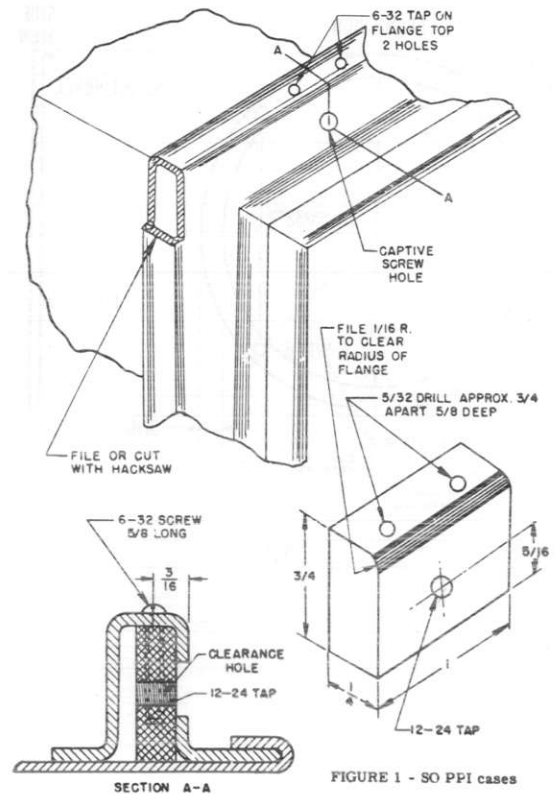
FIGURE 1 - SO PPI cases

The following suggestion for salvaging Radar Equipment SO P.P.I. cases has been adopted as an improved salvage method. The cases are discarded due to loosened or damaged captive-screw nuts.

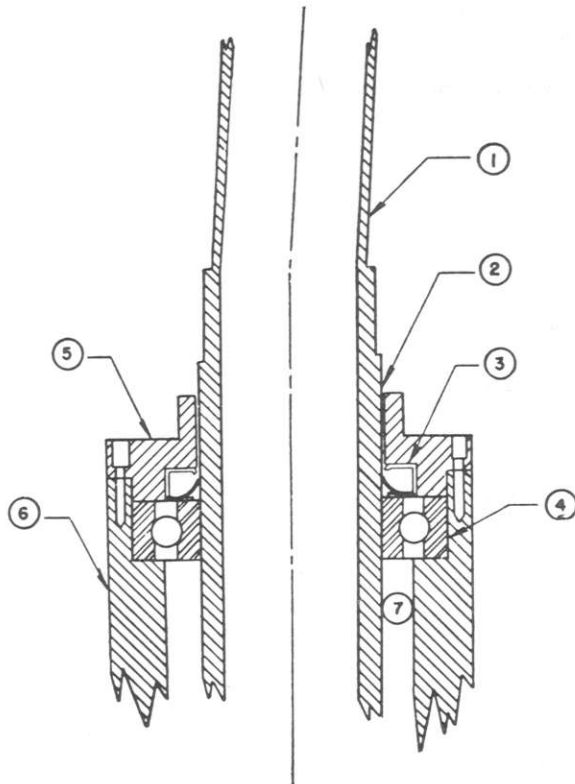
FIGURE 1.—Rotating waveguide, oil seal, and bearing.

Replacement oil seals are available.

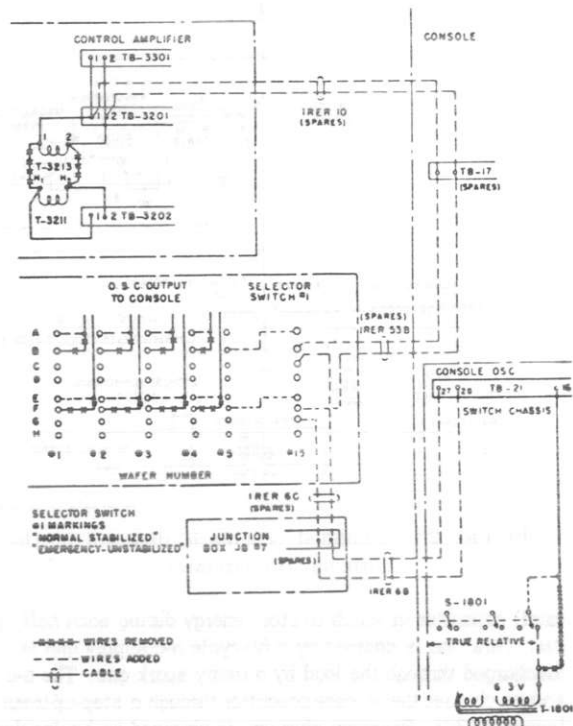
FIGURE 1.—Schematic wiring diagram in SP Selector Switch No. 1 and accompanying components showing method of making changes necessary to accomplish unstabilized, true-bearing operation.

After the wiring changes are completed, energize the system and test for proper azimuth positioning. If any 180° errors are present and new wiring is correct in terminal to terminal interconnections, examine old wiring to locate double errors that were formerly self-compensating.

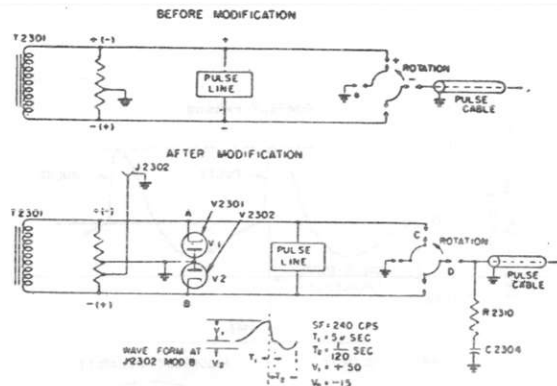
FIGURE 6.—Simplified schematic diagram of a portion of the B-modulator before and after Field Change 26 has been installed.

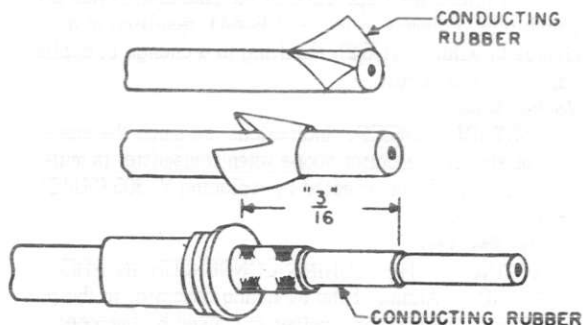
FIGURE 1.

UG-36/U CONNECTOR BREAKDOWN: Several reports have been received reporting the breakdown of the UG 36/U connector used on the RG-27/U cable to the SRa modulator. Investigation discloses that the breakdowns have resulted because of the failure to cut back and remove layer of conducting rubber which lies between the inner shielding braid and the dielectric. This conducting rubber layer must be removed to a distance of three-sixteenths inch from the brass washer on the connector. Figure 1 illustrates a section of RG-27/U cable showing the various layers with the conducting layer to be removed.

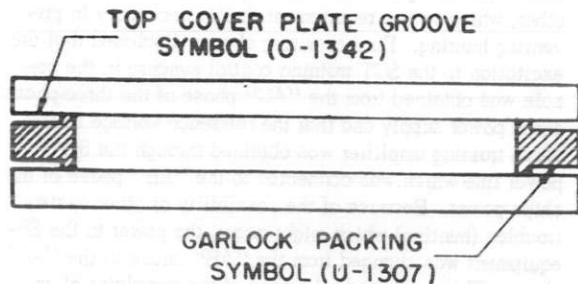
FIGURE 1.—Cross-sectional view showing Garlock Packing Ring properly installed with wide dimension against bottom of groove in top cover plate.

There are two possible ways in which the Garlock Packing Ring can be installed into the groove. One side of the packing has a slightly larger dimension than the opposite side. The proper way to install the packing is to insert the side with the larger dimension first as shown in figure 1. It will have to be forced into the groove before it is seated. Also make certain that the two ends of the packing ring are cut clean at a 45° angle. Any frayed edges should be trimmed.

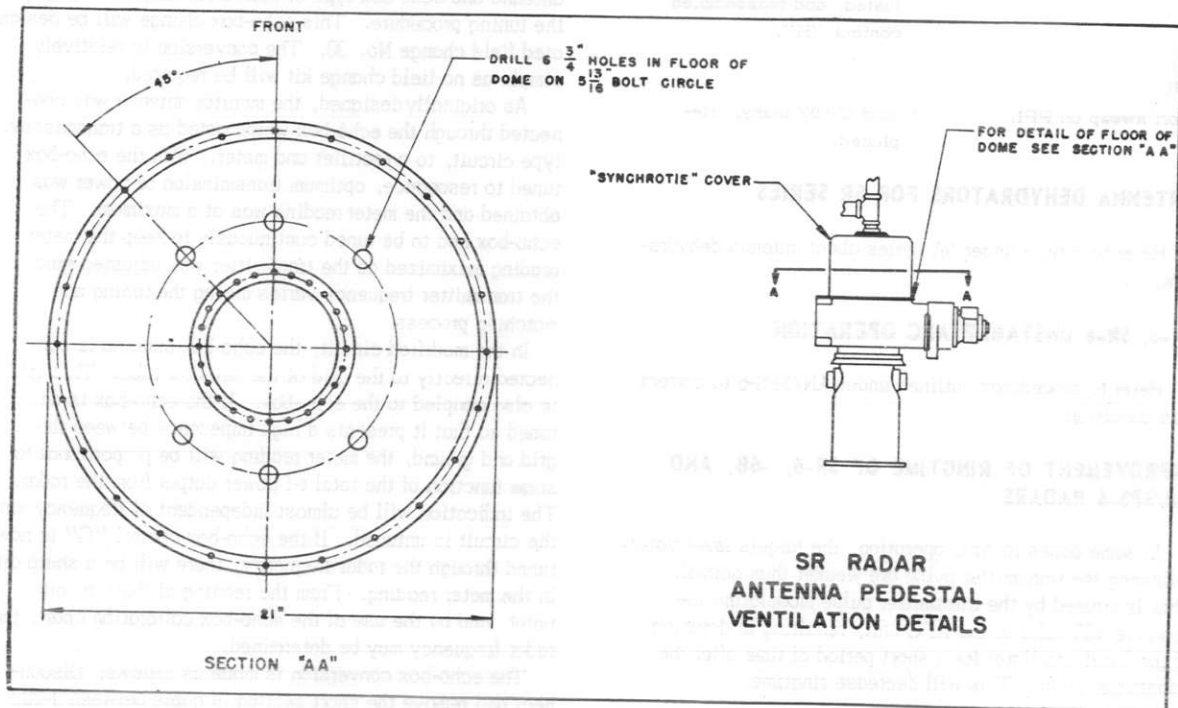
FIGURE 1.

To reduce the condensation of moisture and corrosion of the synchro units and associated equipment in Model SR/SR_a Radar Antenna Pedestal, the Mare Island Naval Shipyard has suggested that ventilation holes be drilled in the separation plates between the upper and lower part, as detailed in figure 1, to allow warm air from the lower section to circulate through the upper dome. This is an easy way to keep the dome dry and it is suggested that the holes be drilled during the next antenna overhaul.

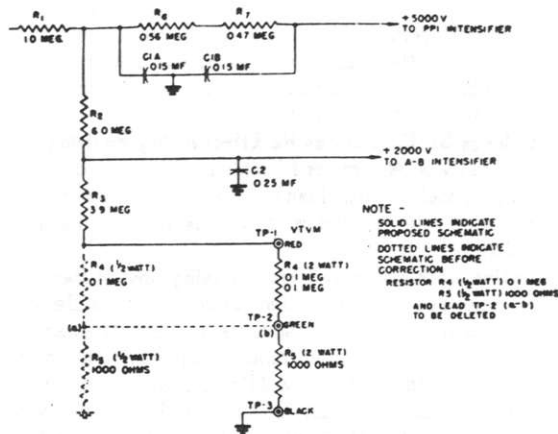
In view of their particular location, 1/2-watt resistors symbols R-4(1H) and R-5(1H) (see fig. 1, schematic-dotted lines) are considered very fragile. They are frequently broken when unit 1H of either Model SS or Model SV-1 consoles is placed into the rack. These two resistors are

FIGURE 1.—Schematic.

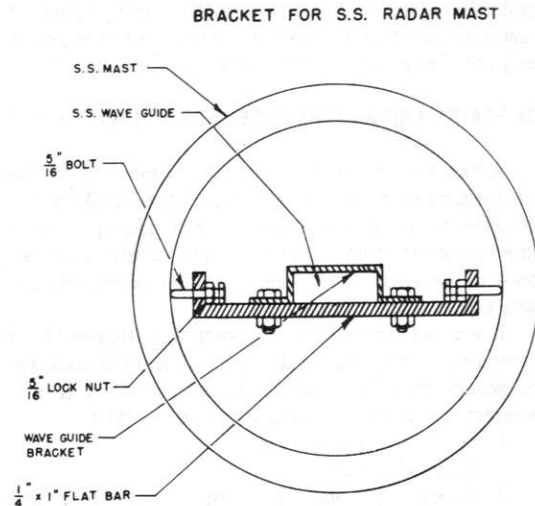
Figure 1.

A suggestion has been submitted for a bracket, as shown in figure 1, mounted near the lower end of the mast, to prevent the waveguide from dropping out during installation.

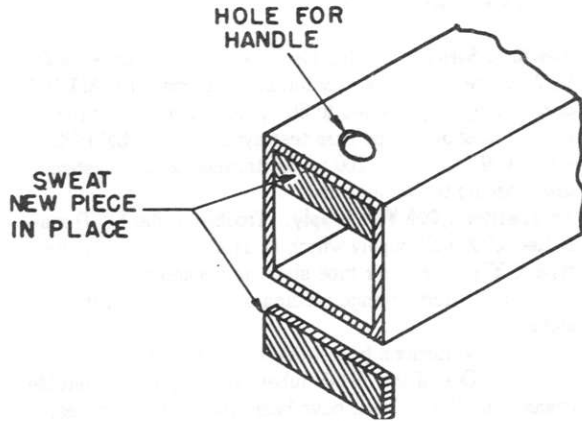
This trouble was brought to the attention of the Bell Laboratories and they advise that a reinforcing member has been added in later production to avoid recurrence of this damage to the block.

After the new piece has been added, the block will look something like the sketch above.
