May 20, 1969

SIGNAL DISTORTION ON MODEL 28
AND 35 TELETYPEWRITERS

(Teletypewriter Forces)

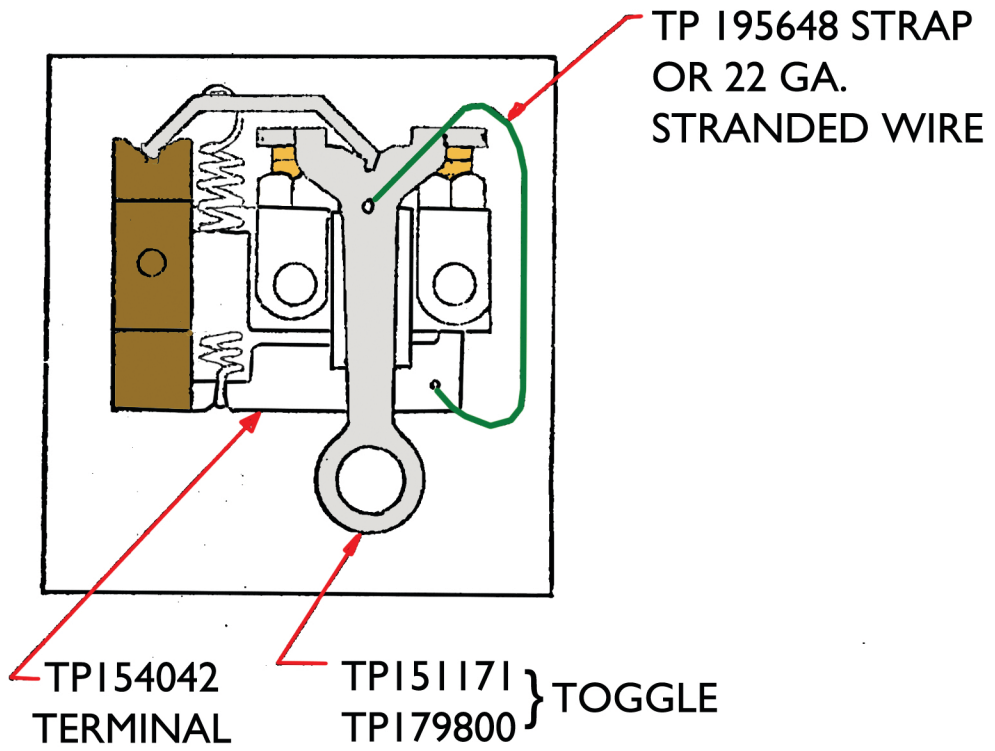
SIGNAL GENERATOR

After a thorough investigation their Laboratory tests revealed the appearance of red rust at the point of the toggle link. This rust creates poor conductivity through the signal generator contacts resulting in peaks up to 45% distortion.

To eliminate these problems the Engineers recommend that on all trouble and routine maintenance visits, where signal generator contacts are involved, a strap should be added to provide a more reliable circuit path.

As illustrated in the attachment, using a TP195648 strap or 22 gauge stranded wire, the strapping should be accomplished in the following manner:

- A. For 28 type equipment add strap between the contact toggle (TP151171) and the terminal (TP154042).
- B. For 35 type equipment add strap between the contact toggle (TP179800) and the terminal (TP154042).
