AN/SPS-39, 42 RADAR-IMPROVED TWT OPERATION

AN/UNQ-7 ELIMINATION OF SHOCK HAZARD

ORIGINAL**AN/URN-3 EMERGENCY REPAIR OF TACAN ANTENNA**

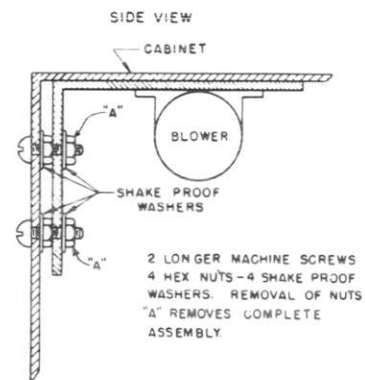
Figure 1

Shake proof washers and hex nuts are run down and tightened, after which the bracket and motor blower is set in place and secured with shakeproof washers and hex nuts. (See figure 1).

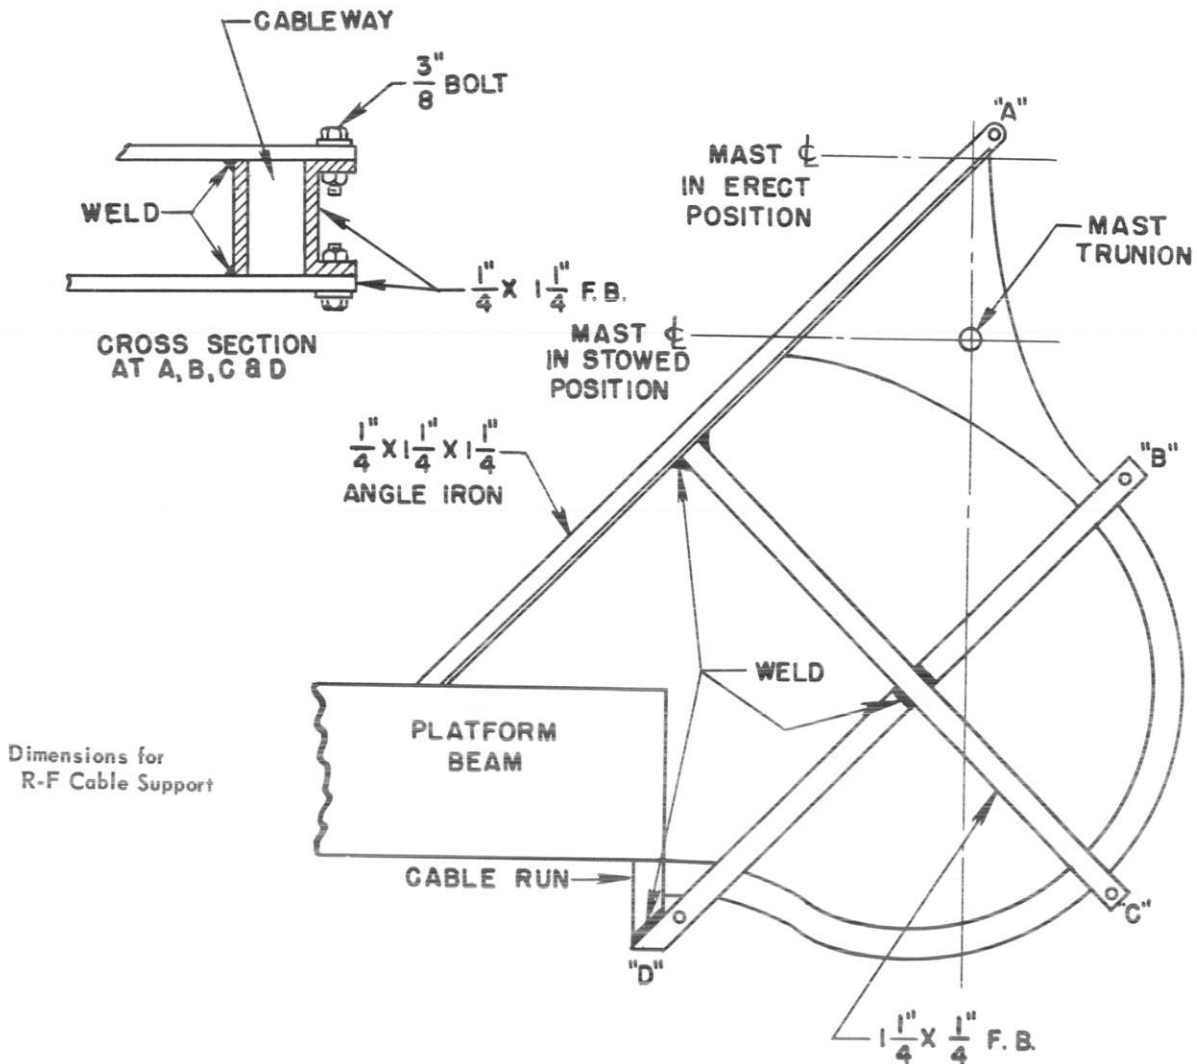
Figure 1

An improved method for supporting Radio-Frequency Cable, RG/24U, at the fulcrum of the tilting mast of DAU equipment by means of a cable support. This method was used successfully for installing the DAU on the USS Essex (CVA9). The cable support is described herein is shown in figure 1. It requires only a 45-degree flexure of the cables on a long (20 in.) radius on each side of the straight position during the entire process of erecting and stowing the mast.

The proposed cable support requires less cable since there is no slack-loop, and a minimum radius is used in bringing the cable-run from underneath the operating platform up to the mast. The cable support is stationary, and only the cable moves with the mast. A demountable outer guard on the cable support permits inspection or replacement of the cables.

The Bureau recommends the use of this suggestion for any future installations of DAU equipment on tilting masts in CV34 Class Carriers. The suggestion will be included in the next revision of the **Electronics Installation Practices Manual**, NAVSHIPS 900,171, as a guiding principle for future installations. As tilting masts are used on a relatively few aircraft carriers, installation plans will not be changed and modification of existing installations is not recommended.
