ELIMINATING SO-a INTERFERENCE TO TCS RECEIVERS

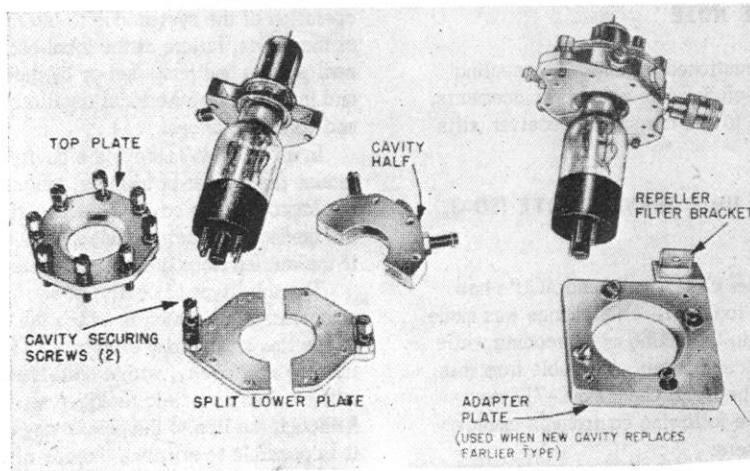
FIGURE 3.

The third type of cavity, shown in figure 3, is of a completely new design in which the tendency toward bending of the lips is virtually eliminated. It is likely, however, that the new cavity, with a suitable adapter (see fig. 3), will be used as a field replacement for the early types. Although the lips in the new cavity are not likely to bend, it is possible to strip the threads of the tuning plugs if the plug locknuts are over-tightened.

Assembly Procedure for New-Type Cavities: The new-style cavity (fig. 3) differs mechanically from the early types and therefore requires a different assembly procedure. To replace a defective local-oscillator tube, proceed as follows:

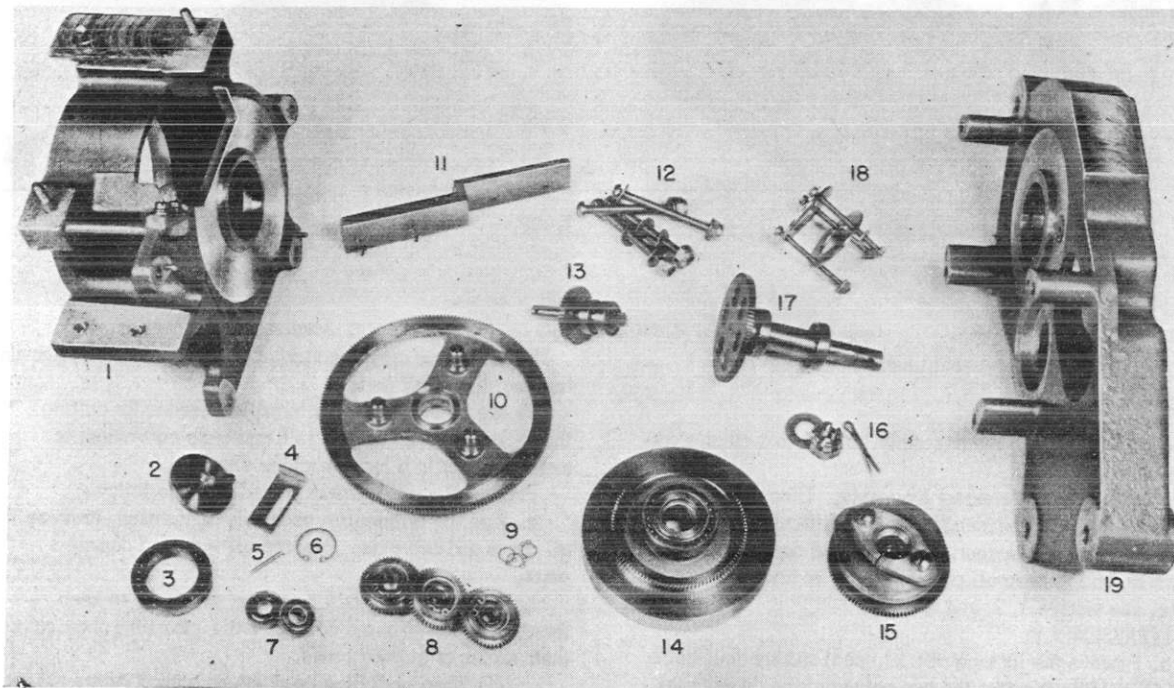
FIGURE 1.—Nomenclature of parts.

General: Many of the Bendix 5SF synchros used in Equipments Affected have been failing because of defective bearings (see SO Bulletin 112-Navy Field Change 96). Bearing failure usually causes the synchro to lock, which results in the breaking of the weakest mechanical link between the antenna and the synchro. In antennas not yet modified for true bearing (CRP-66AGE), the weakest link seems to be the gear that is locked by the small clip (see item 10 in fig. 1; and fig. 3). When the synchro jams on these antennas, the clip strips the teeth off the gear.

REPLACING PARTS: Figure 1 illustrates and names most of the differential parts, indicating the Raytheon part numbers and the quantities required. Replacement parts should be ordered by parts numbers only.

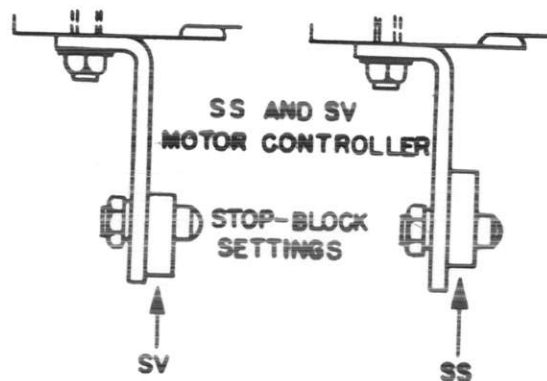
Figure 1

There have been many cases where the PPI has failed to follow the antenna. This trouble resulted from antenna scan speeds in excess of the 8-9 RPM for which the servo system was designed. For normal operation, the maximum output of the Motor Controller should be 116 plus or minus 4 volts. Use of the 135 volts maximum output (incorrectly shown in instruction book drawings) will cause excessive antenna speeds. The 135 volts is applicable to the SV equipment.

Setting of the maximum voltages at the factory for the SS and SV equipments is accomplished by positioning a stop block for the scotch yoke of the Motor Controller. The illustration shows correct stop-block settings for SS and SV equipments. In NAVSHIPS 91513, page 7-421, figure 7-230, the block position shown is for the SV equipment only.

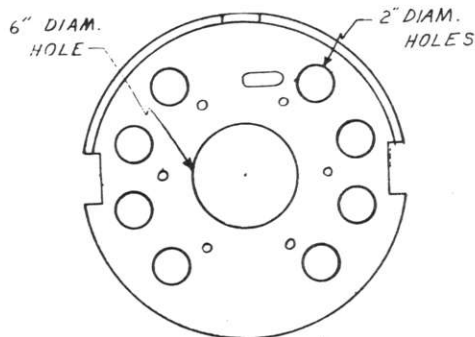
Figure 1

i.e., in a position below where the guide bars are effective, but above the periscope well bumper. This can result in severe damage to the waveguide stop. Also, this additional weight can lead repair personnel to think the adapter springs, item 18, figure 7-149, NAVSHIPS 91513, are weak, resulting in unnecessary replacement of the springs.

A solution to this problem is to remove 10 lbs. of the additional weight by cutting 9 holes. A 6-inch diameter hole is cut in the center and eight, 2-inch diameter holes are cut as shown in figure 1. The strength of this number is not critically affected by cutting these holes.

Further lightening of the bottom plate assembly can be accomplished by removing a triangular shaped piece of metal from each guide flange. This would help relieve the weight unbalance of the bottom assembly.

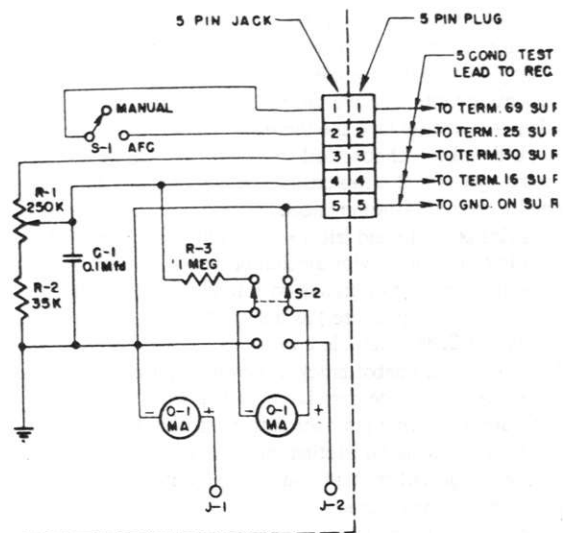
SU "Local Control Unit"; Schematic

The 'TR' and 'ATR' tubes can be more accurately tuned when targets are observed at the transmitter-receiver unit. A synchroscope, such as the TS-34/AP, can be connected to the video output jack through a 'tee' connector. A trigger pulse can be obtained from either terminals, A or B, located on the front of the magnetron pulse transformer assembly.

The use of the LOCAL CONTROL UNIT is simple and quite satisfactory, giving accuracy in tuning which is difficult to achieve by other means.

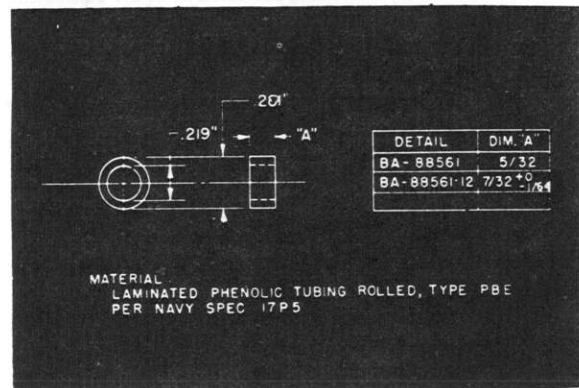
FIGURE 1.—Insulating bushing.

In the SV and SV-3 radars the magnetron is insulated from ground by phenolic insulating rings and insulating bushings. This is necessary in order to obtain magnetron current readings on the test meter. When these bushings become damaged or the rings broken the magnetron frame becomes grounded and current readings are unobtainable. Furthermore, these bushings and rings are not in spare parts and replacement becomes very difficult.

To enable maintenance personnel to fabricate these rings and bushings locally the following manufacturing data is supplied. Two magnetron insulators, two insulating bushings 7/32 inch high and eight insulating bushings 5/32 inch high are required.
