Monterey, California. Naval Postgraduate School

**THE MITIGATION OF
RADIO NOISE AND INTERFERENCE
FROM ON-SITE SOURCES
at
RADIO RECEIVING SITES**

November 2009

Wilbur R. Vincent
George F. Munsch
Richard W. Adler
Andrew A. Parker

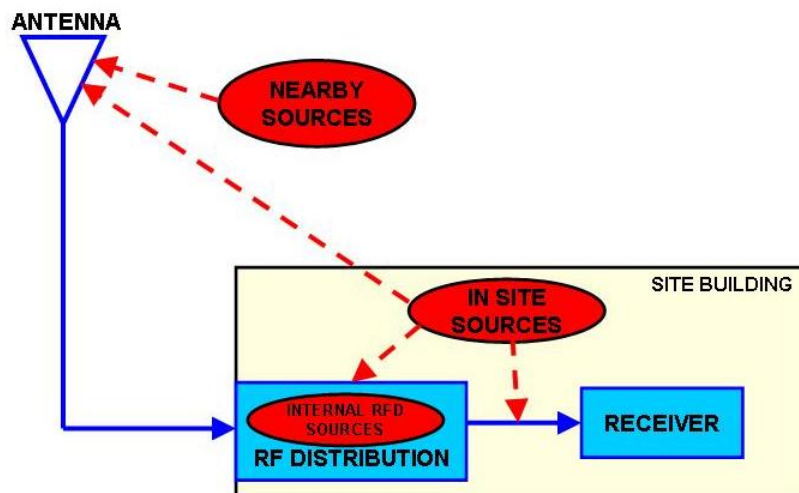
Many sites have outlying facilities which also contain sources of noise. These are shown by the red oval titled "Nearby Sources," and noise from such sources can be received by the site's antenna and be passed along to the input terminals of a receiver. Other sources can be inside the receiver building where it can leak into the RF paths by a variety of mechanisms. Still other sources of radio noise can be generated by filters, switches, amplifiers, and other components within the RF distribution system which are saturated thus generating intermodulation products and intermodulation noise.

Figure 1 Block Diagram of On-Site Sources

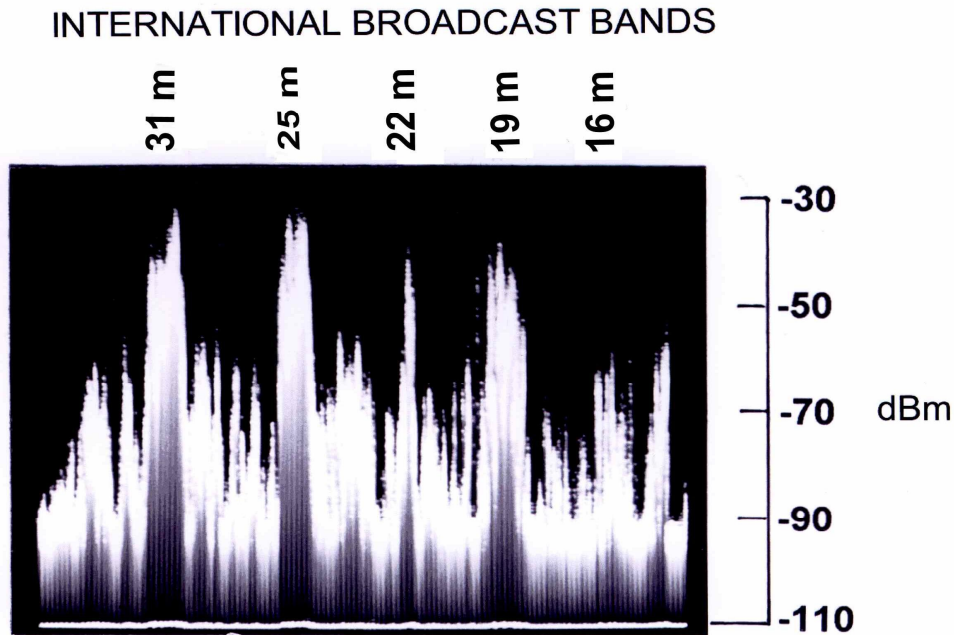
At nighttime when ionospheric absorption is low, HF signals will be 30- to 50-dB higher in amplitude than shown in Figure 2.

Figure 2 Example of Daytime Signal Levels in the HF Band

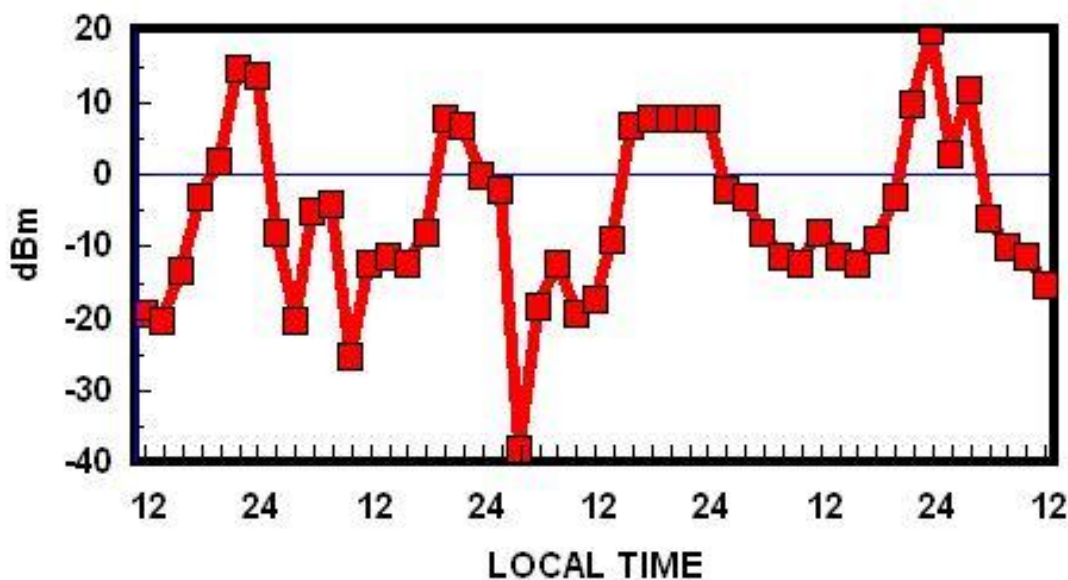
Figure 3 Diurnal Variations in Total HF Received Signal Power

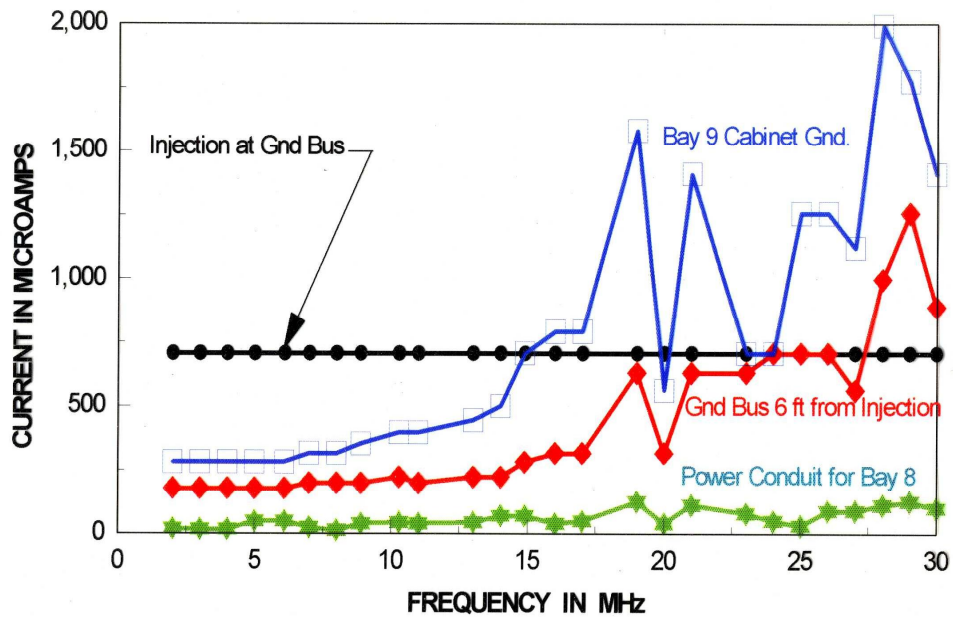
Figure 5 shows an example of standing waves along ground conductors for two equipment racks and along the conduit providing power to the racks. EMI current was injected into a ground bus at the power panel supplying power to equipment in the racks. Current was injected at a series of fixed frequencies and at a level of 750 μA rms. The injection level was set to the ambient broadband EMI current level flowing on the ground bus at a frequency of 2 MHz at this receiving site. The blue curve shows the measured current flowing in a ground bus at an equipment rack located about 10 feet from the injection point and as the injection frequency was varied. Peaks and nulls were found with frequency similar to the peaks and nulls found on a transmission line or an electrically long antenna. At the high-frequency end of the data, current peaks on the ground bus significantly exceeded the injection level.

Figure 5 Standing waves along Ground Conductors

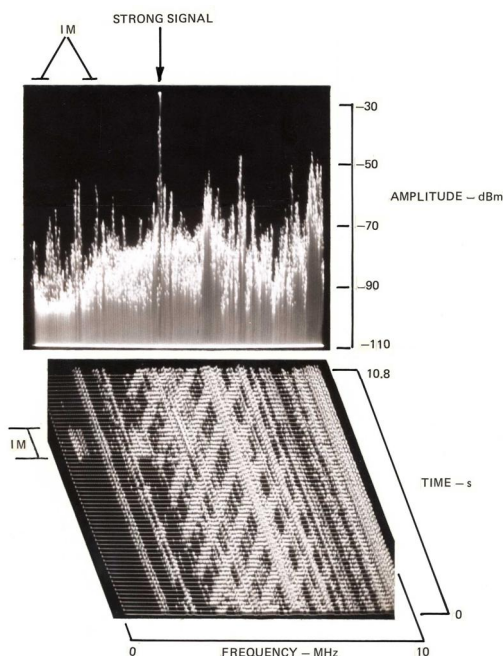
Figure 7 shows a brief burst of intermodulation noise caused by a strong signal burst that overloaded the amplifier of a multicoupler. Such bursts of IM noise can be similar to some short-duration signals, and when present they put an unwanted burden on a receiving system which must differentiate them from desired signals.

Figure 7 In-Band IM Noise

The previous Figure 7 shows one example where a strong signal about one-second in duration produced IM products and noise also about one-second in duration. Even shorter duration IM products and noise can occur, and Figure 9 shows an example. In this case a frequency-hopping transmitter emitting pulses in the low portion of the VHF band was operated adjacent to a receiving facility. Its strong VHF signals overloaded components in the RF path and produced high-level impulses of IM noise from 60 MHz up to 1000 MHz. Figure 9 shows an example of the resulting IM pulses in a 10-MHz wide portion of the radio spectrum centered at 309 MHz.

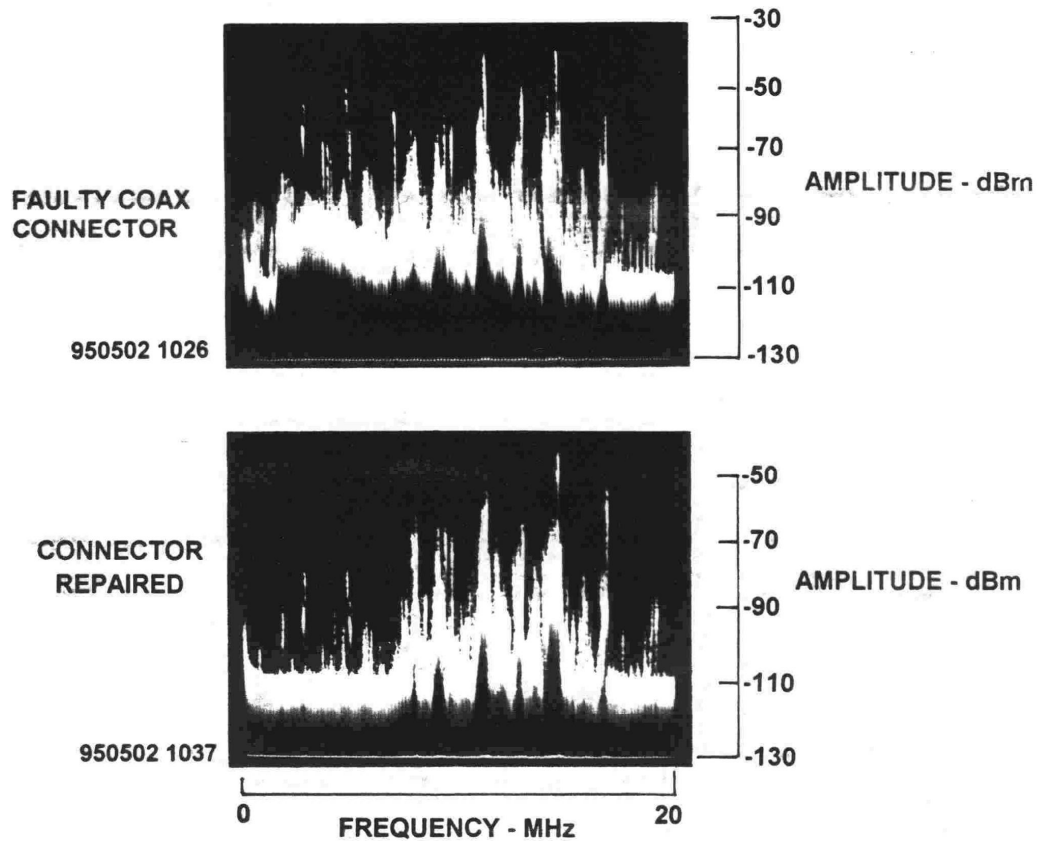
The upper view of Figure 12 shows signals and noise at the input terminals of a receiver when an improperly assembled coaxial connector was installed on a coaxial cable in the RF-Distribution path for that receiver. The shield of the cable was open at one end enabling EMI current and voltage on the cable shield to enter the signal path. The noise floor over the low-frequency portion of the frequency range is excessively high. The lower view shows the reduction in the noise floor when the shield was properly connected.

Figure 12 Impact of Improperly Assembled Coaxial Connector on Noise Level

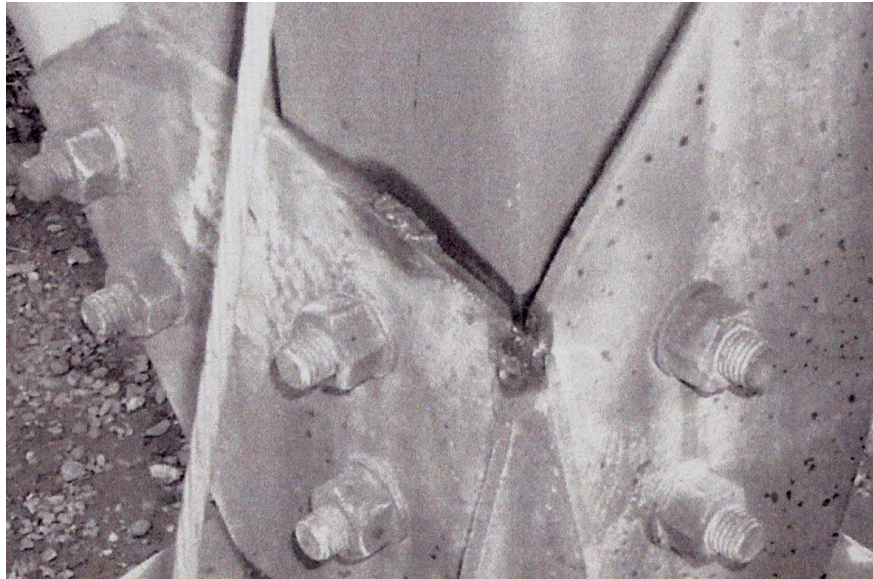
Figure 13 shows an example of a weld on a galvanized portion of an antenna tower at a receiving site. This tower was located on a hilltop receiving site in direct line of sight to television, FM, and AM broadcast transmitters as well as being close to other commercial and military communication sites. Such sources injected significant levels of current and voltage into the tower and its associated cable shields. If nonlinear joints are present on such structures, intermodulation products and broadband intermodulation noise sources will exist.

Figure 13 Weld on Galvanized Metal of a Receiving Antenna Tower

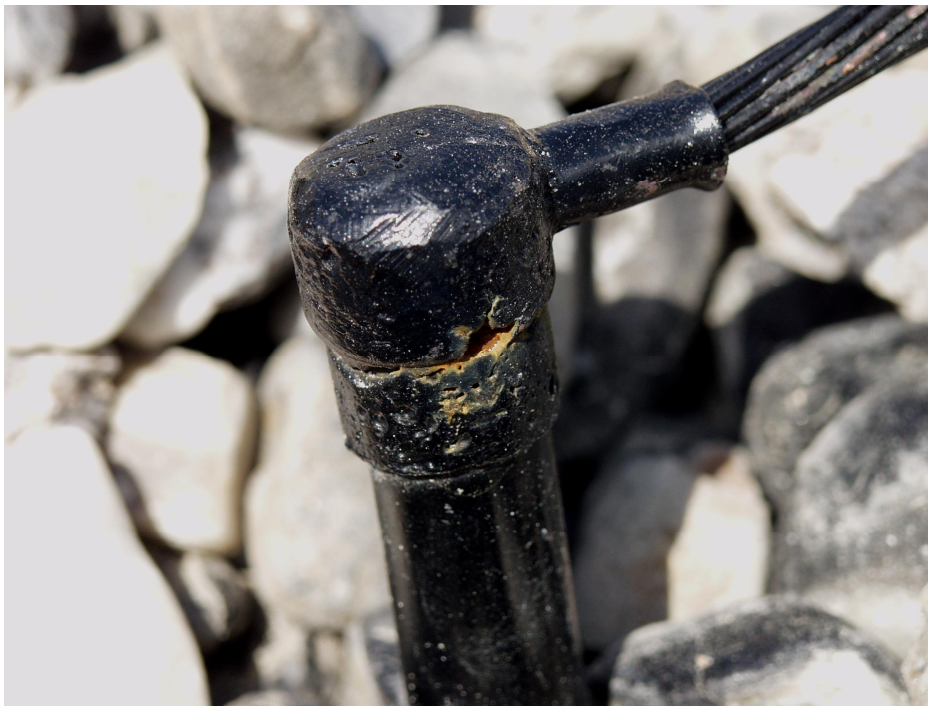
The use of mechanical electrical fittings fabricated of bronze will eliminate the possibility of these connections being sources of low-level intermodulation products and noise in the antenna counterpoise system. This will also eliminate the high levels of intermodulation when nearby radio transmitters are operated. CADWELD[®] joints should not be used on or near antenna fields or at any other location within or near a receiving site.

Figure 15 CADWELD[®] on Antenna Counterpoise Wire

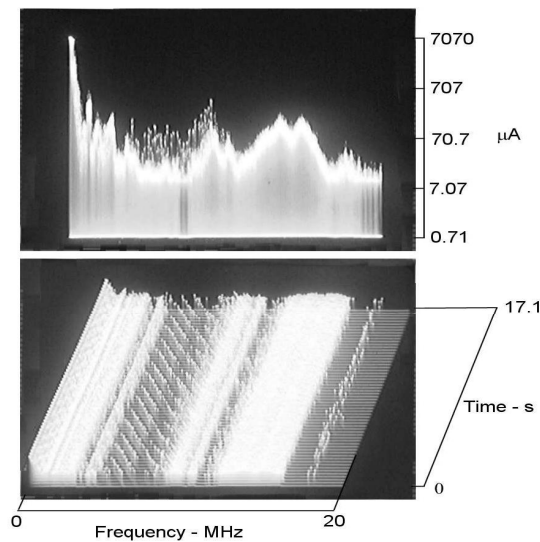
A few examples of excessive EMI current flowing on cables in a receiving site will demonstrate the problem. Figure 21 shows EMI current flowing on one of the 3-phase output power conductors of a Power Distribution Unit (PDU) over the frequency range of 100 kHz up to 10 MHz. This particular PDU was located within a shielded room that housed the RF-distribution equipment for an HF receiving site. The PDU contained a switching power supply for its electronics along with other digital control devices, and it provided electric power to all equipment located within the shielded room.

Severe peaks and nulls in noise amplitude were found across the entire frequency range of the data at levels significantly above the minimum tolerable level provided in Table 1. The slanting lines in the time-history view over the frequency range of about 3.5 to 8 MHz are from repetitive impulsive noise with a period of 8.3 ms (a pulse occurrence rate of 120 per second). The amplitude of these impulses is shown in the upper amplitude-vs.-frequency view. The noise in the remaining part of the HF band was a combination of impulsive noise at lower levels and closely-spaced spectral components related to harmonics of the power-line frequency and of the switching rate of the power-converter device.

The PDU was examined to determine if it was procured in accordance with the FCC Class B noise voltage rating. No label was found on the unit, a violation of the FCC rules. While the voltage level of noise was not measured in accordance with the FCC test procedures, the high noise current level clearly indicate this unit was either manufactured to the FCC Class A industrial noise requirement or the noise requirement was simply ignored.

An examination of the power-conversion devices contributing to the harmful levels of radio noise in Figures 21, 22 and 23 did not reveal the expected Class B or Class A labels required by the FCC for such devices marketed for general sale. Additional examination and measurements indicated that all were intended for industrial use rather than meeting the FCC Class B requirement for residential use. The use of such devices in and near a radio receiving site can significantly degrade the ability of a site to receive low-level radio signals of special interest, and they should not be installed in such facilities.

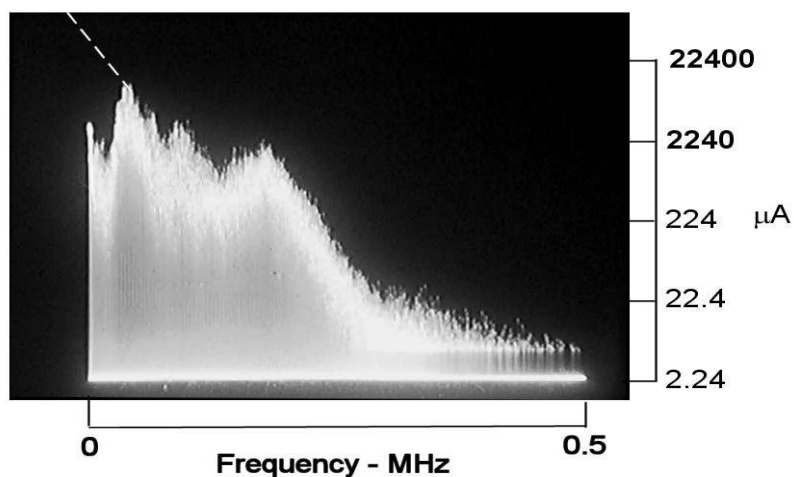
Figure 22 shows noise on one of the 3-phase conductors feeding power into the shielded room. In this case the power is provided to a 30-kVA UPS located in an adjacent shielded room, and it passed through a large low-pass filter located on the UPS side of the wall of the shield separating the two rooms. The drop in noise amplitude above about 200 kHz is caused by the filter. Note that the noise level at 500 kHz is very low, and the device met the requirements of Table 1 for a large site at all frequencies above about 1 MHz. The filter installation was effective at the higher frequencies, but excessive levels of noise and harmonic components of the power-line frequency and the switching rate of the UPS exceeded the low-frequency level stated in Table 1.

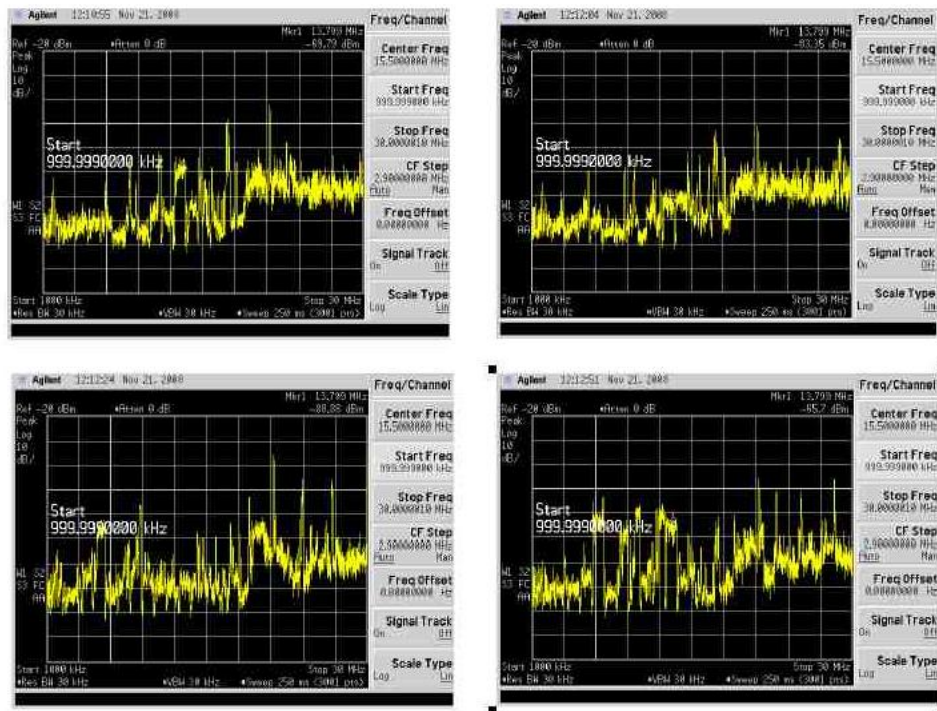
Figure 30 shows an example of erratic noise and interference found over the 1- to 20-MHz portion of the HF band at a receiving site where the data was obtained with a conventional scanning spectrum analyzer. Four sequential scans are shown where the spacing between the first two scans is about 20 seconds, and the spacing between the other examples is only a few seconds. A careful examination of the four examples shows significant differences in detail from one to the next one. The spectral and temporal properties of the noise and interference changed significantly from example to

example, and the changes cannot be understood from such sequential examples. These examples illustrate the difficulty in describing erratic noise and interference with standard instruments.

Figure 30 Example of Erratic Noise and Interference

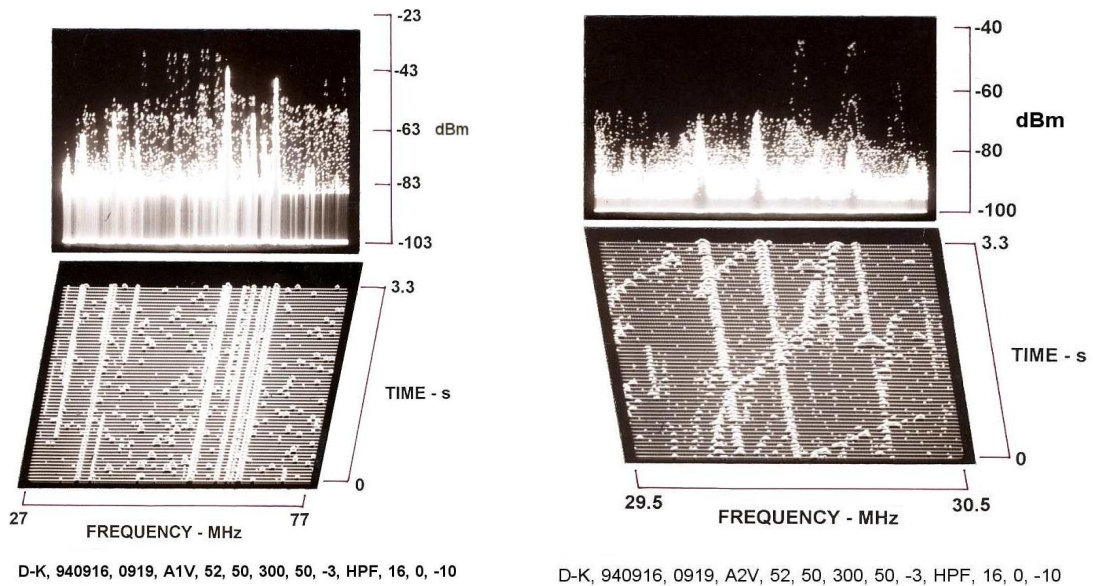
The right view shows variable-frequency emissions causing intermittent interference to an HF receiver. In this case, multiple emissions from the radio-frequency heaters of multiple plastic molding machines caused the intermittent interference. Such emissions are permitted for the Industrial, Scientific and Medical (ISM) radio service within the band of $27.120 \text{ MHz} \pm 160 \text{ kHz}$. The emissions originated from a factory located more than 10 km from the receiving site, and the emissions are clearly outside their allocated frequency band.

Figure 32 Intermittent Interference from Frequency-Hopping and ISM Emissions

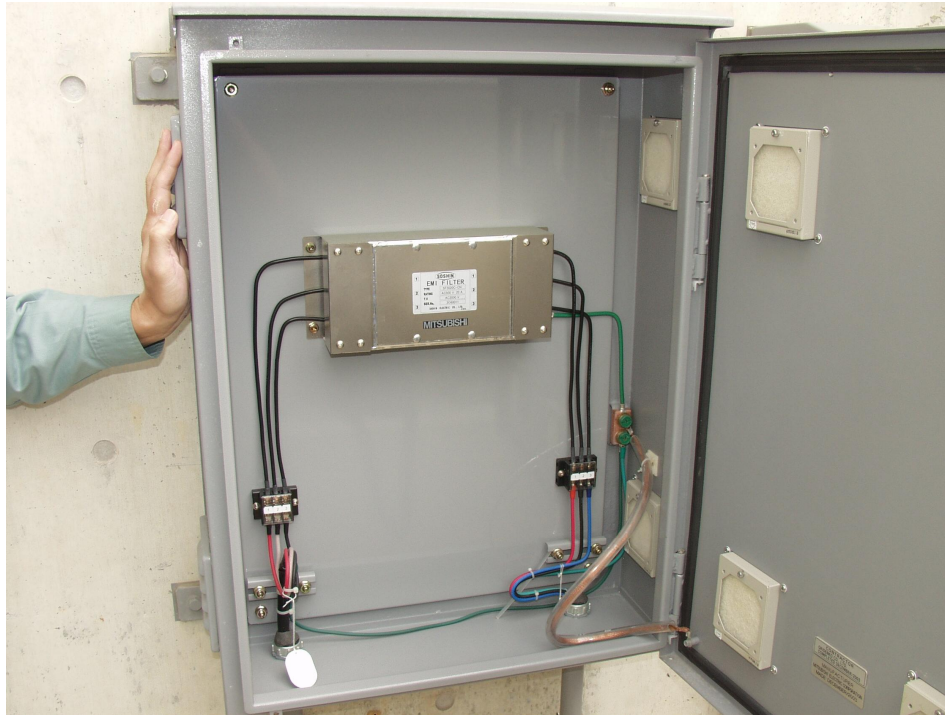
Figure 49 Improper Filter Configuration

Several improper aspects of the filter installation resulted in the total lack of suppression of a severe electromagnetic impulsive noise problem. These aspects were:
